**General Electric Advanced Technology Manual**

**Chapter 7.2**

**Oyster Creek Log Summary**

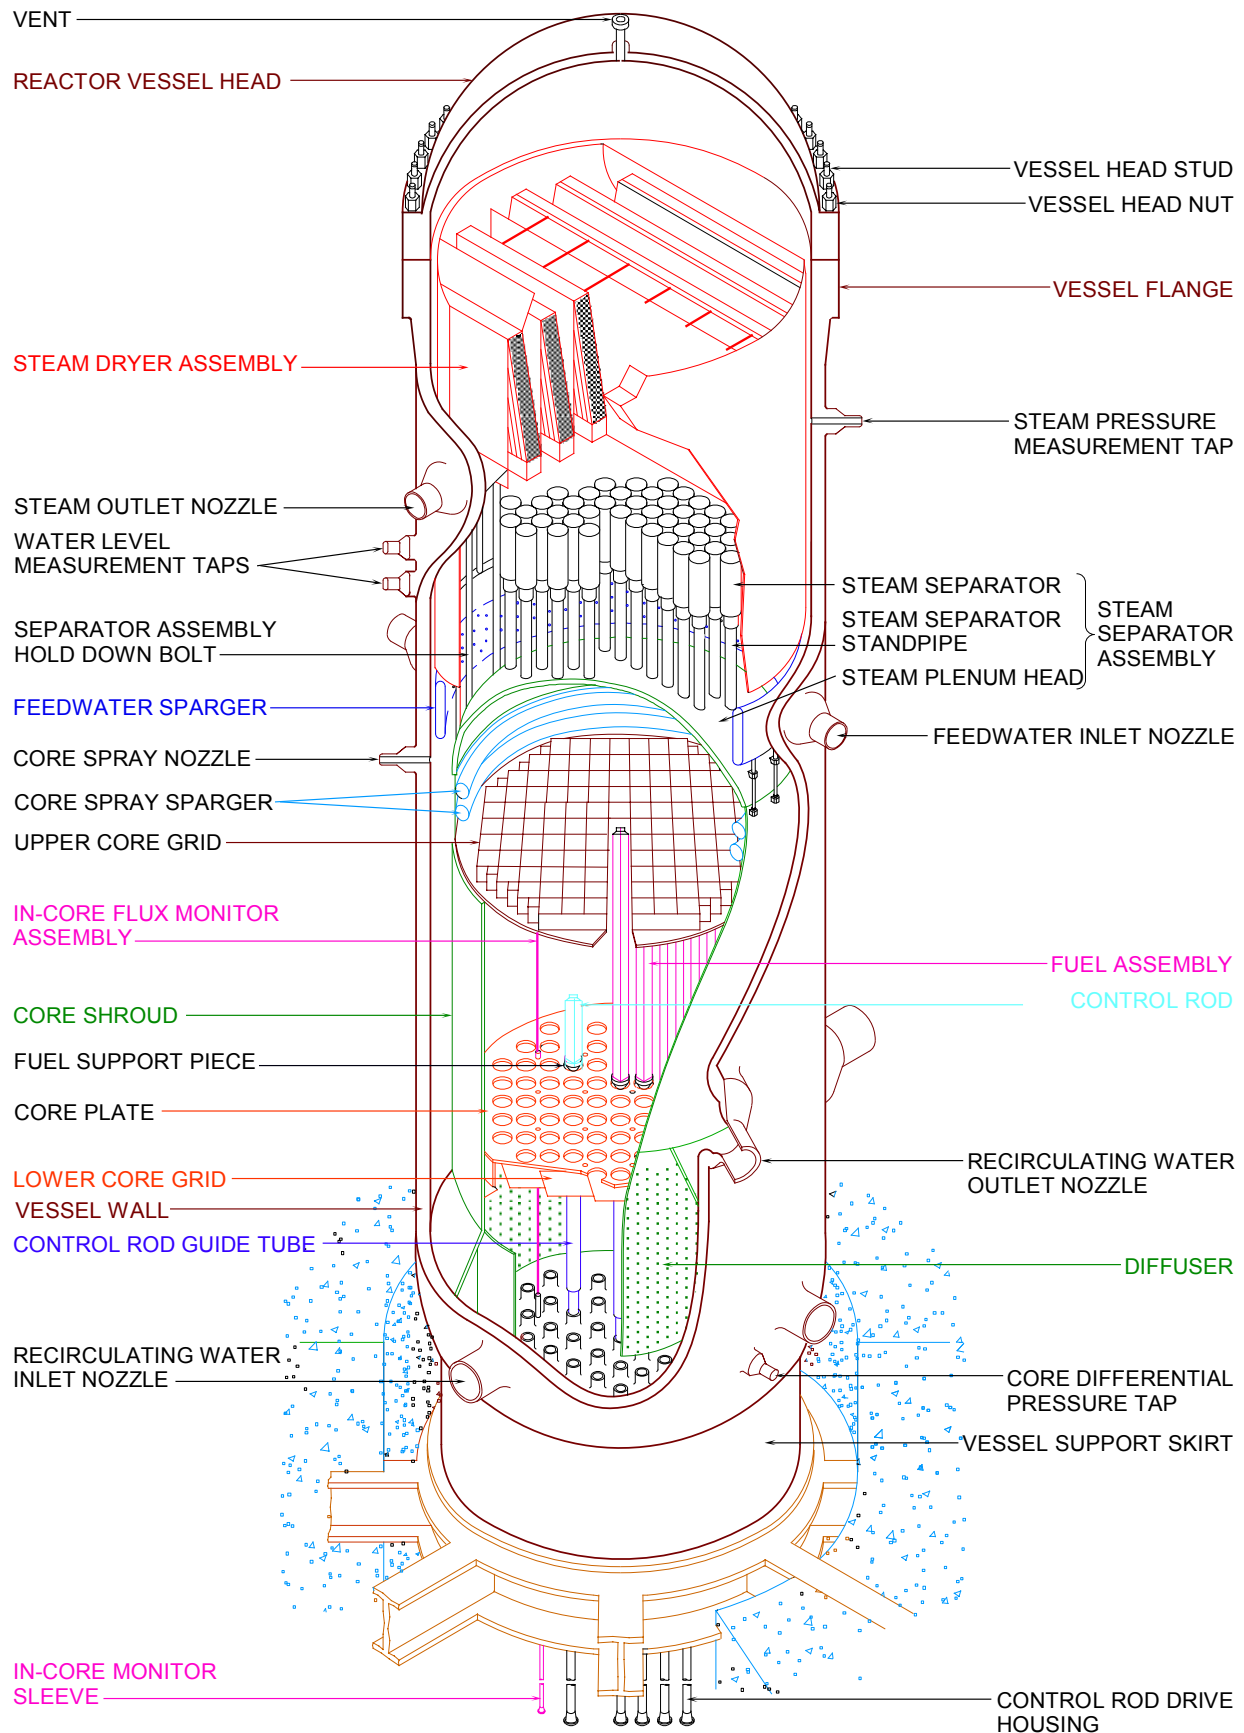
**Figure 7.2-1 BWR/2 Reactor Vessel**

Unlike other BWRs the BWR/2 reactor vessels do not have direct communication from the annulus region to the core inlet plenum. Water must exit the reactor vessel via recirculation loops and then reenter the vessel bottom head.

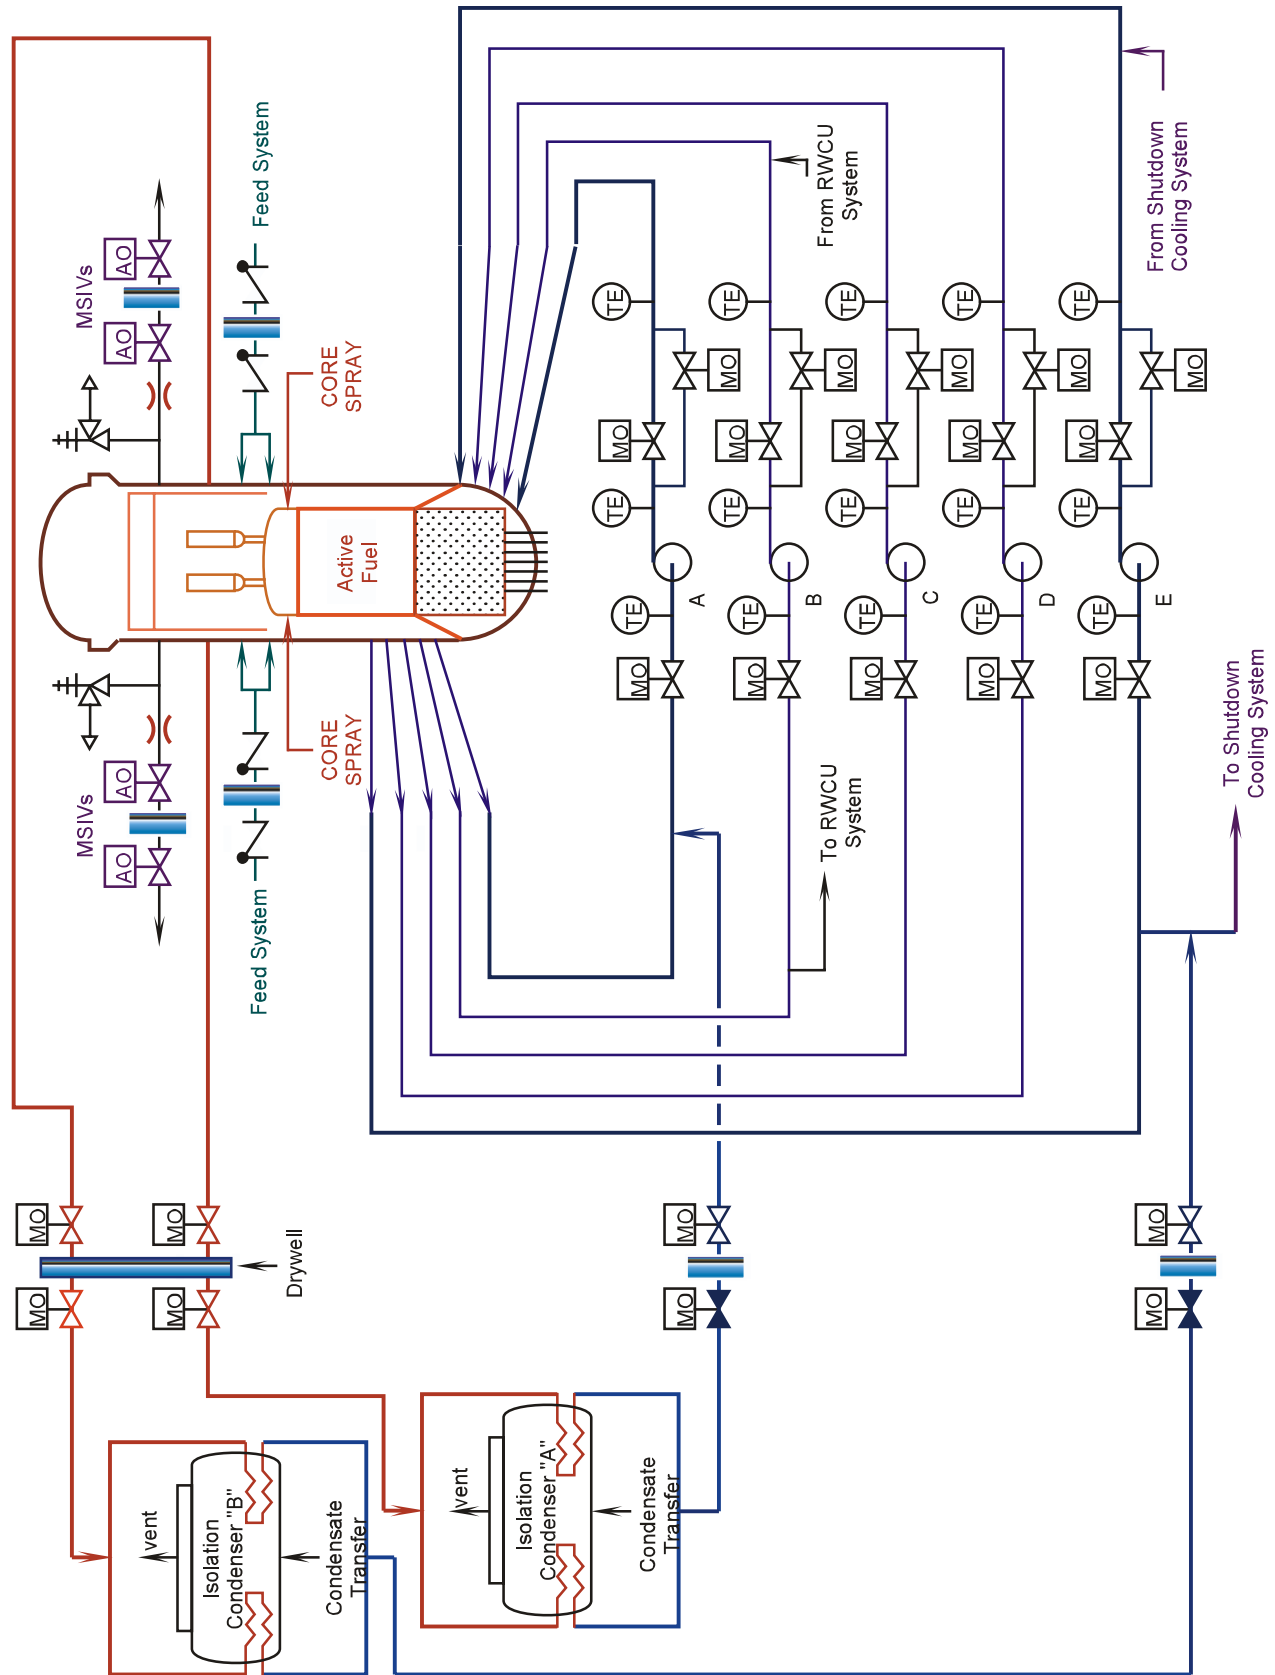
Figure 7.2-2 BWR/2 Isolation Condenser and Recirculation Systems

In anticipation of low-low water level (level 2), automatic isolation of the reactor, the operator closed the MSIVs. To establish a heat sink to remove decay heat from the reactor, the B isolation condenser was placed into service (Figure 7.2-2). The operator closed the A and E recirculation loop discharge valves (stroke time is approximately 2 minutes). It was postulated that the remaining two loops were also closed by the operator. The conclusion that the five recirculation pump discharge valves were closed was based upon subsequent loop temperature changes observed later in the event.

The temperature of the E recirculation loop decreased due to the addition of cold water from the isolation condenser condensate return line. Loops A, B, and C temperatures increased slightly which was attributed to natural circulation forcing hot water (536°F) through the loops that were previously cooled by the addition of cold feedwater.

Water inventory shifted from the core area to the downcomer region due to the isolation condenser returning condensed steam from the core area to the downcomer. The water inventory shift continued as the discharge valves moved in the closed direction.

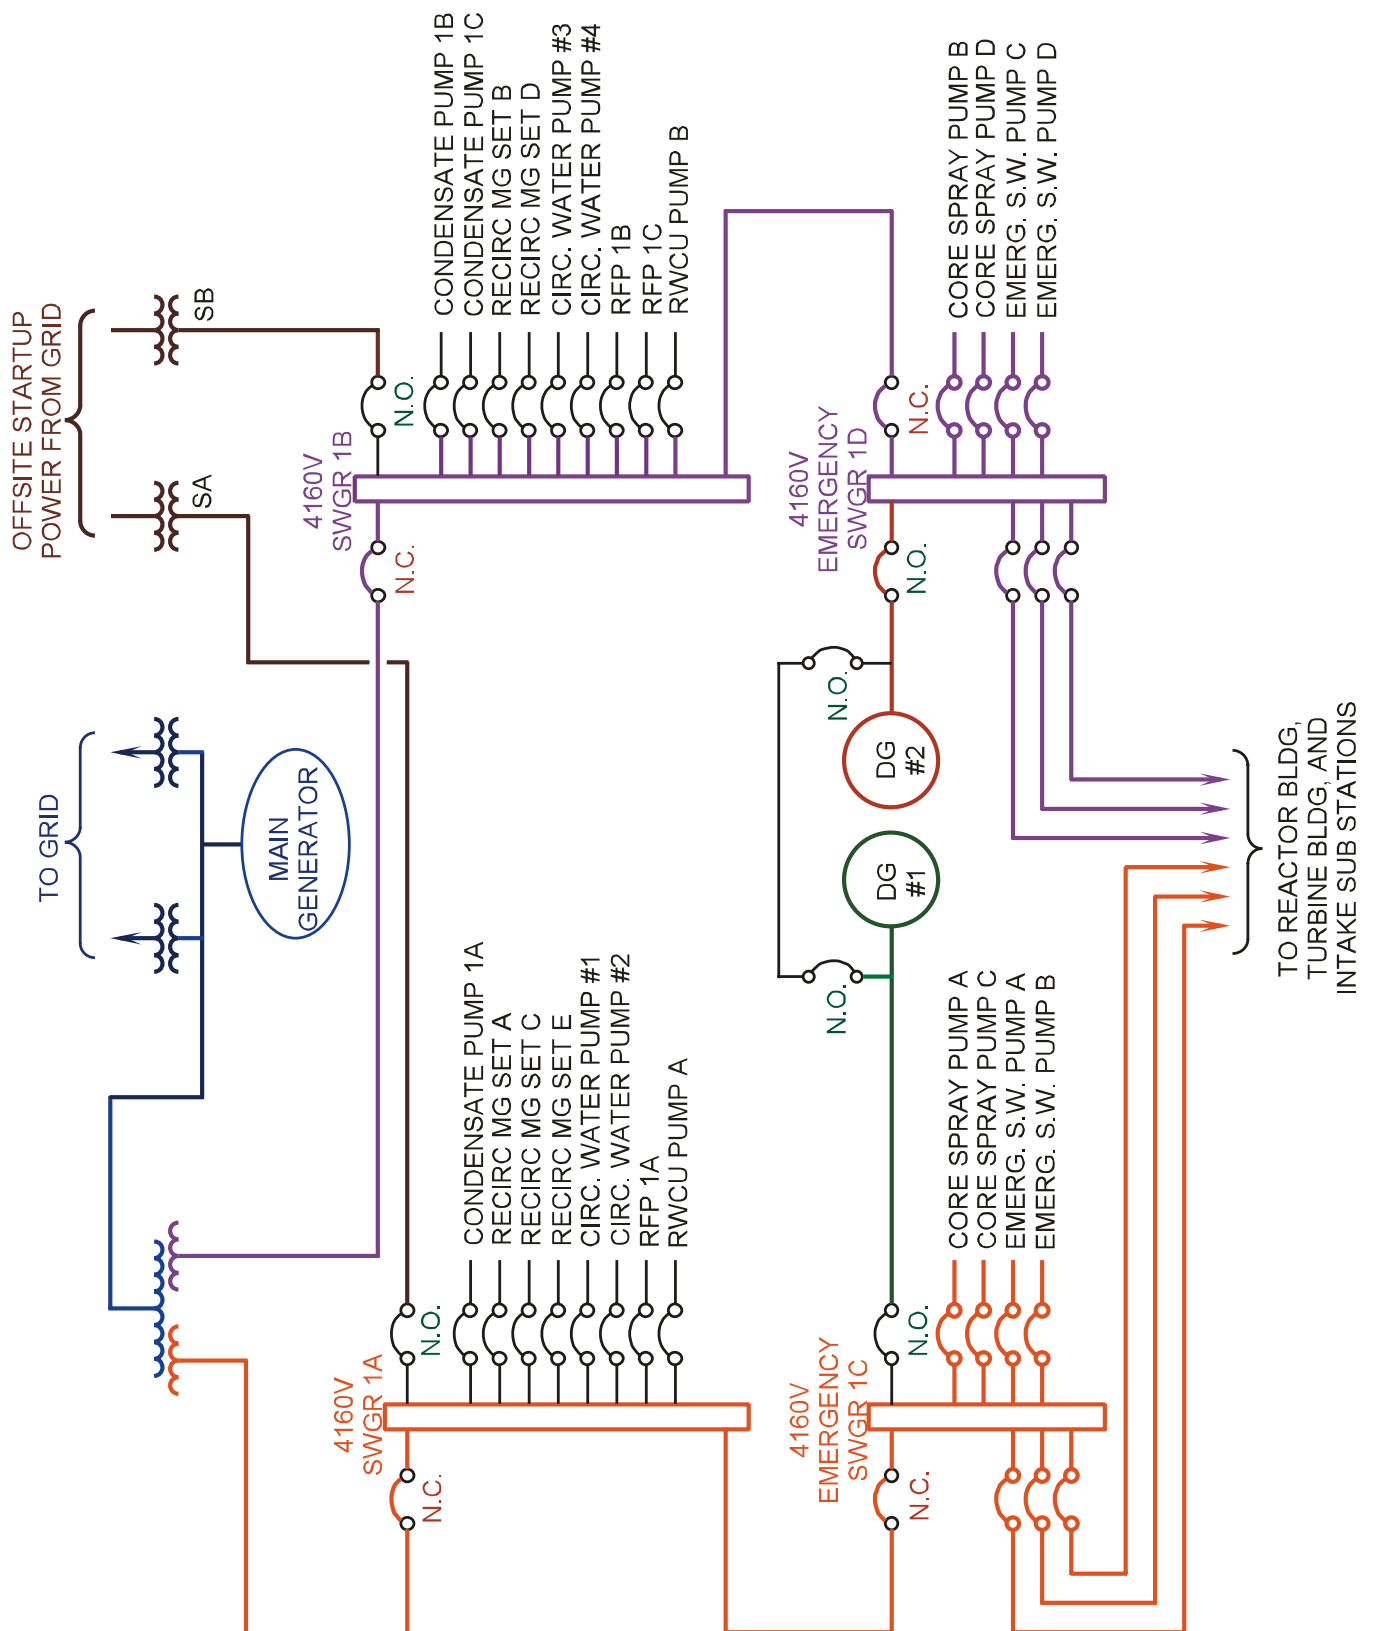
Figure 7.2-3 Oyster Creek Electrical Distribution

One of two startup transformers, SB, was out of service to perform an inspection of its associated 4160 volt cabling (permitted by Technical Specifications). Transformer SB supplies off site power to one half of the station electrical distribution system (Figure 7.2-1) when power is not available through the station auxiliary transformer. The 4160 volt busses which receive power from SB are 1B and 1D. Buss 1D supplies power to certain redundant safety systems and is designed to be powered from the number 2 diesel generator in the event power is not available from either the auxiliary or startup transformer. Buss 1B supplies 4160 volt power to non-safety related systems and hence, does not have a diesel backup power source.

The turbine generator subsequently tripped on reverse power as designed which initiated an automatic transfer of power to the startup transformers. Power to busses 1A and 1C successfully transferred from the auxiliary transformer to startup transformer SA. Since SB was out of service at this time, power was lost to busses 1B and 1D which caused an automatic start of the number 2 diesel generator.

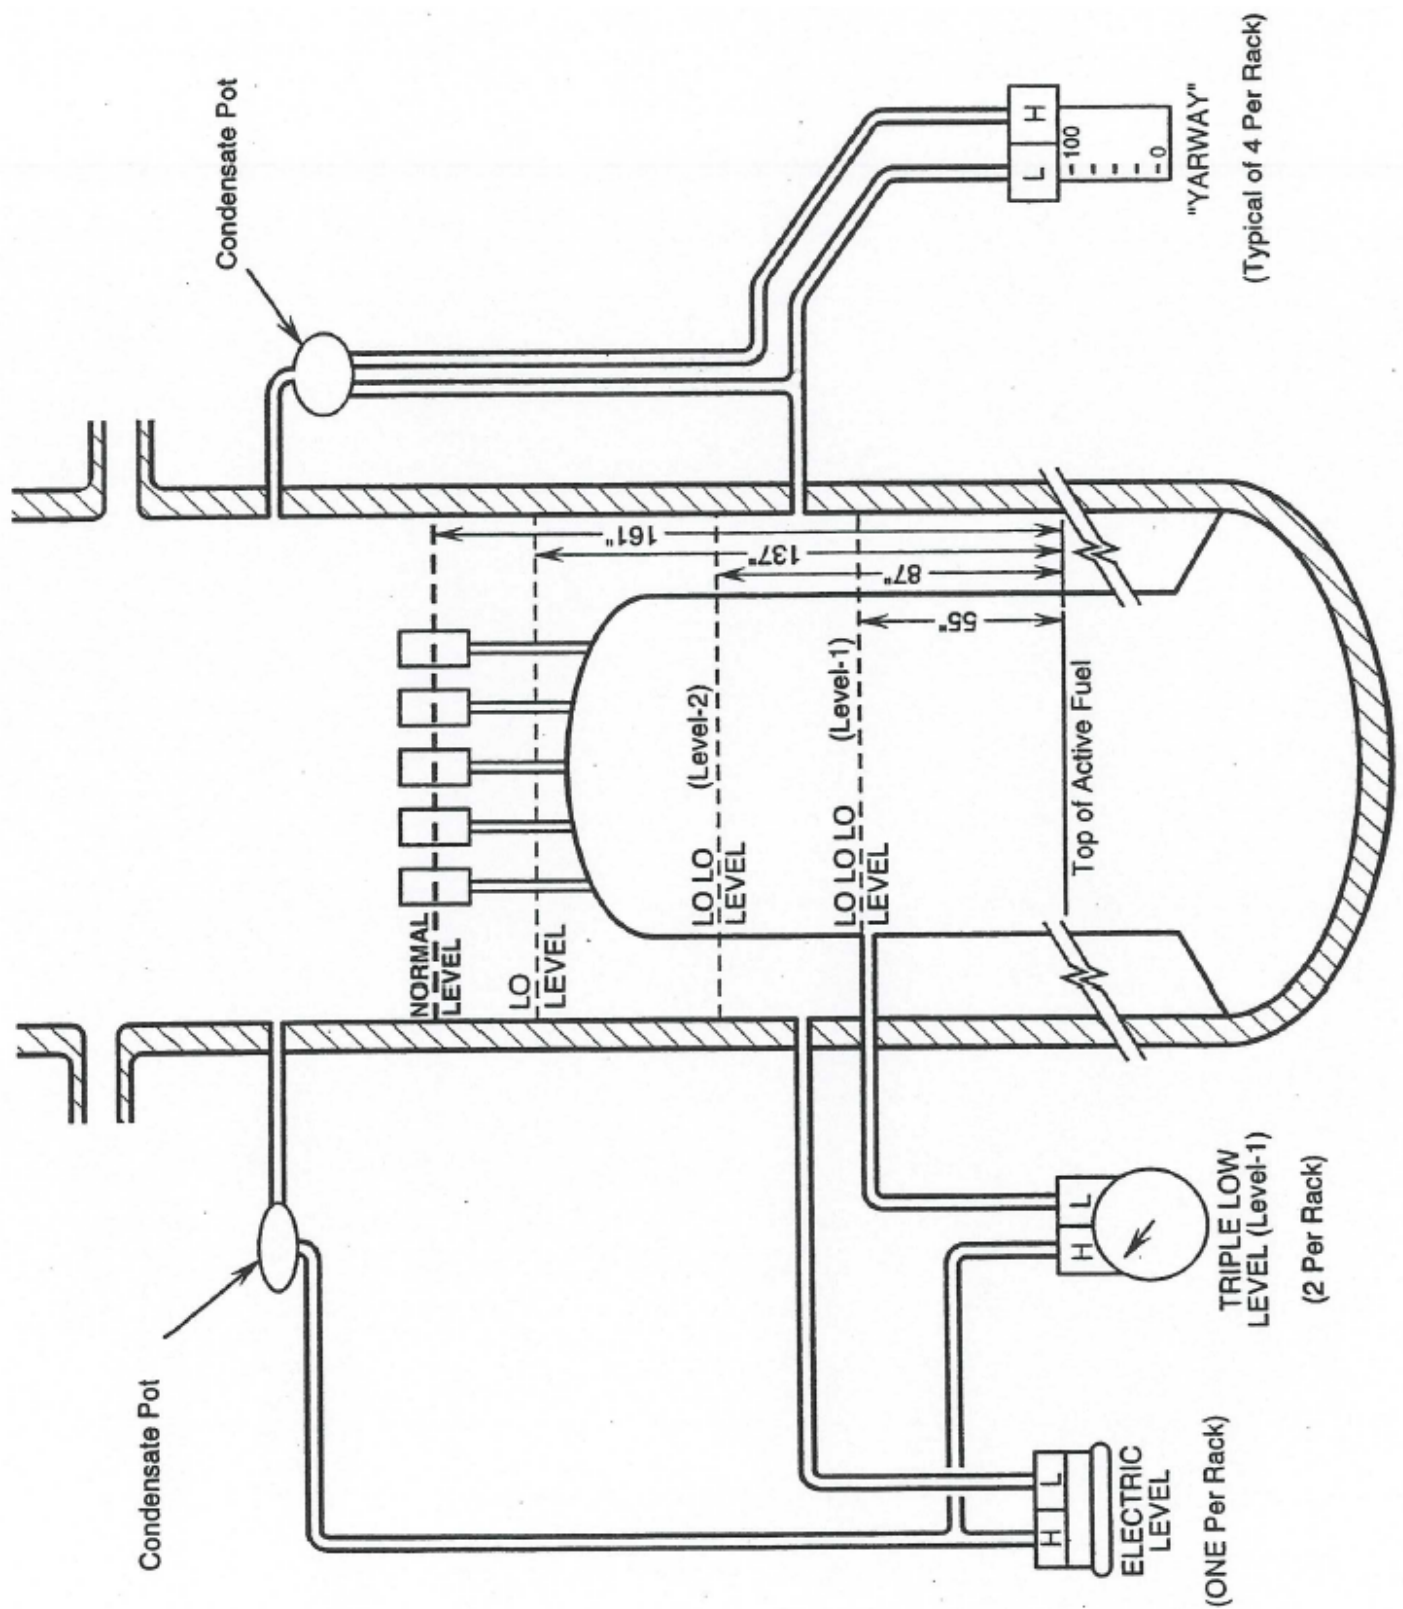
Figure 7.2-4 Oyster Creek Vessel Level Instrumentation

During performance of local alarm verification and indicator checks the low-low-low (level 1) water level indicators were found to be below their alarm setpoint (10 inches). A recheck performed locally showed that the pointers were active (moving) although they continued to read below their alarm point. Also the instruments were indicating at or slightly above their lower level of detection.

The C recirculation pump was started to provide a better indication of the plant cooldown rate. After the pump started, indicated water level dropped approximately 3 feet in less than two minutes causing the operator to stop the pump and investigate the reason for the level drop. In response to the level problem, the operator attempted to start the A feedwater pump. The pump failed to start due to a tripped overload on the auxiliary oil pump which provides an interlock in the feedwater pump starting sequence. The auxiliary oil pump was started locally followed by starting the A Feedwater pump. Indicated water level increased to a level corresponding to 13 feet 8 inches above the top of the core. The operator now recognized that all five recirculation loop discharge valves were closed and indicated water level and actual water level may not have been the same.
